HA-111 MOTZ HOUSE Havre de Grace, Md.

INVENTORY FORM FOR STATE HISTORIC SITES SURVEY

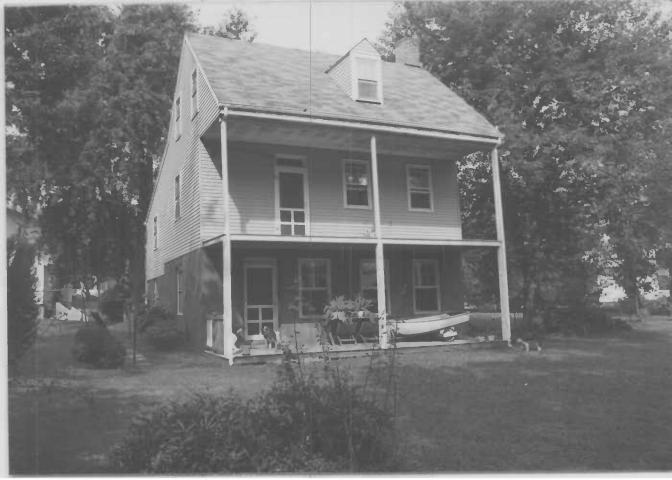
Motz House HA-111 715 N. Stokes St. Haure dé Grace, Md. Southeast e levation

Across the west front is a one story, four bay porch with a shed rocf supported by plain posts. On the river or east side is an open two story, two bay porch, supported by plain wooden posts. It is recessed under the roof and extends across the entire elevation.

On the west front, the house has two entrances, one in either end. Both doors are six paneled, but the north door has six lights in the upper panel. On the river front, the doors have six panels also. They are contained in the south bays; the door on the second story has a three light transom above it.

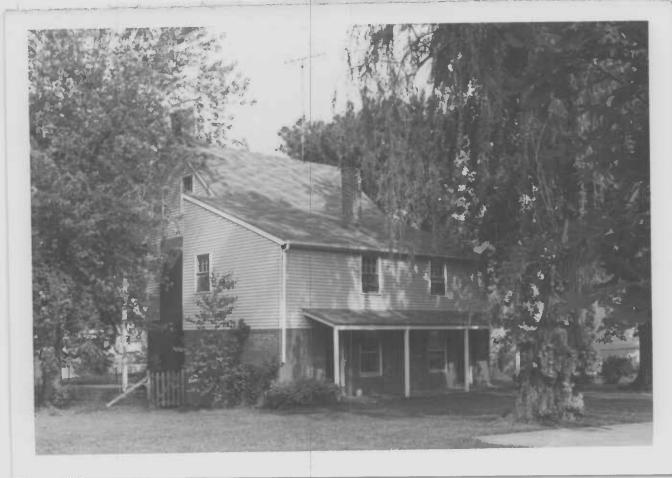
Motz House HA-111
715 N. Stokes St.
Howe do grace

N.W. Elev.
